LAL LAL WIND FARM
YENDON SECTION
Feasibility of haulage routes

LAL LAL WIND FARM –YENDON SECTION FEASIBILITY OF HAULAGE ROUTES

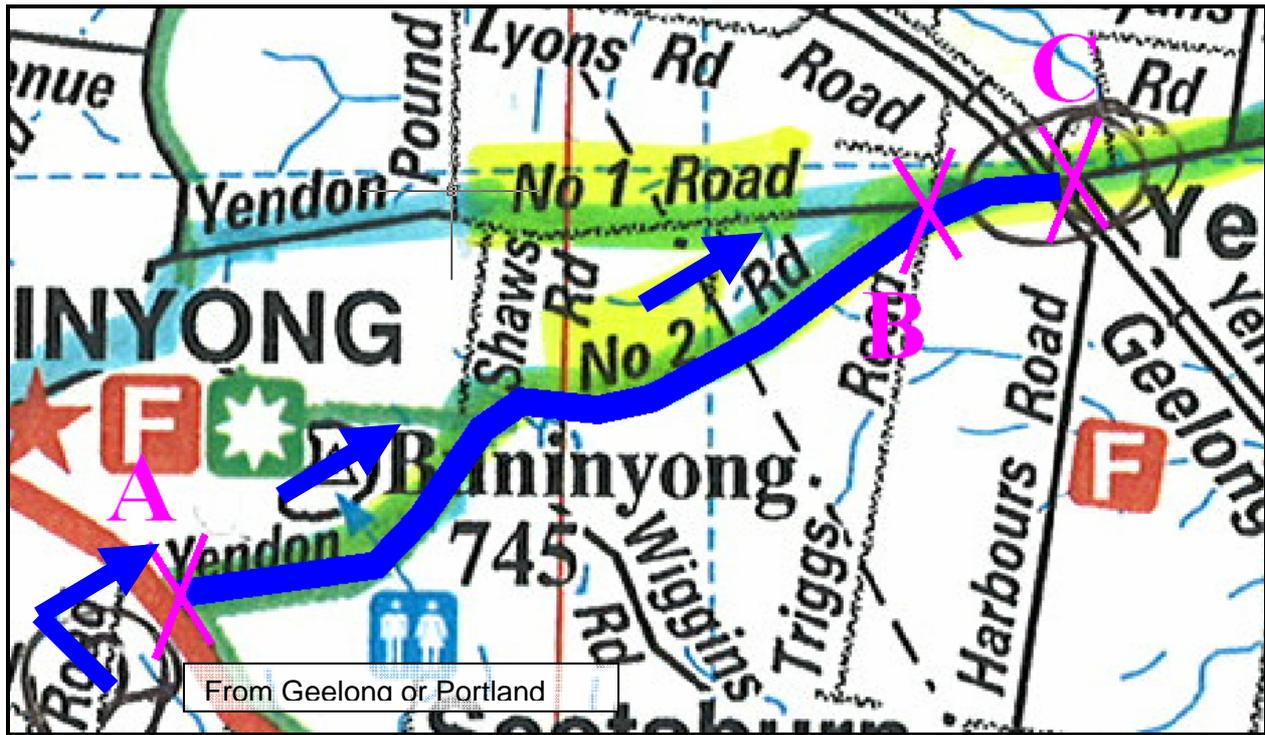
Figure 1 – Yendon Section - Yendon Road No2 Access Route

Access to both sections of the Site is expected to occur from the Midland Highway. For the purposes for this report Cardno Grogan Richards broke-down both sections into segments from A to V in the case of the Elaine Section and segments A to S for the Yendon Section. The following figures depict the routes that were analysed:

Continues on Figure 2

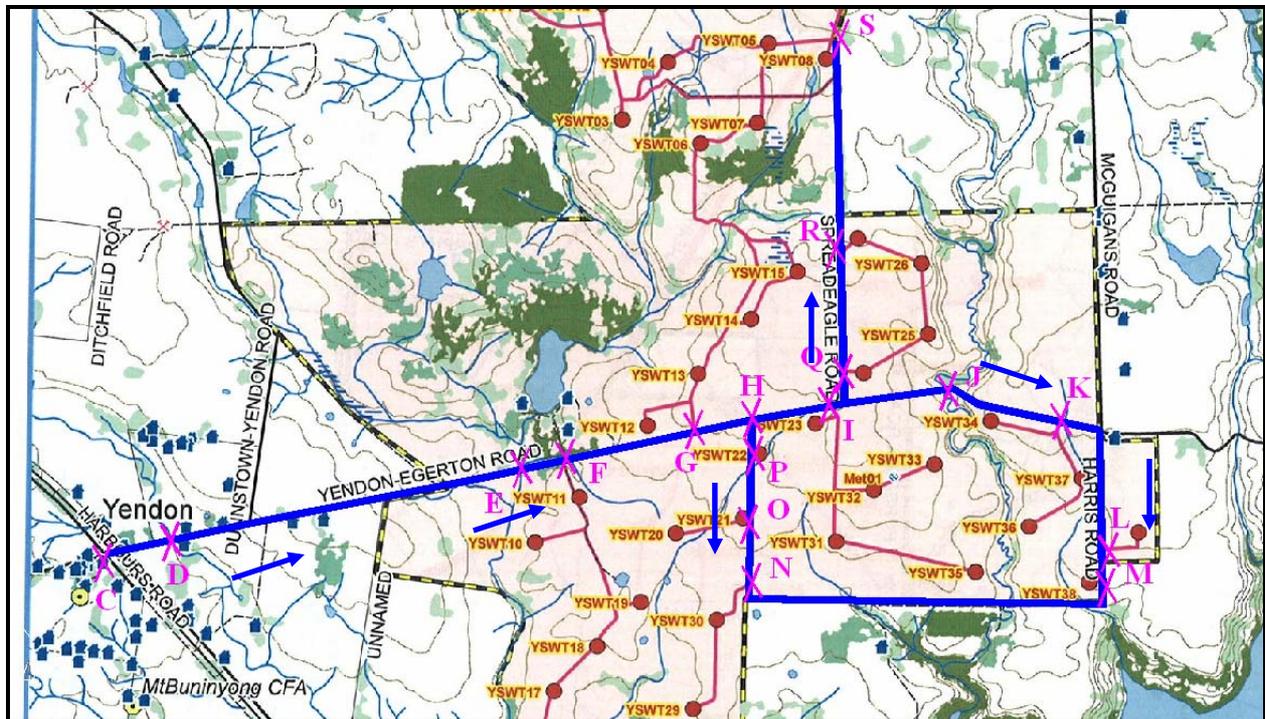
Figure 2 - Yendon Section Routes and Points of Interest

Continues Figure 1

Dunnstow-Yendon Road connects Yendon (see point C on Figure 2 page 2) to Millbrook or to the Western Highway (to the northwest via Warrenheip).

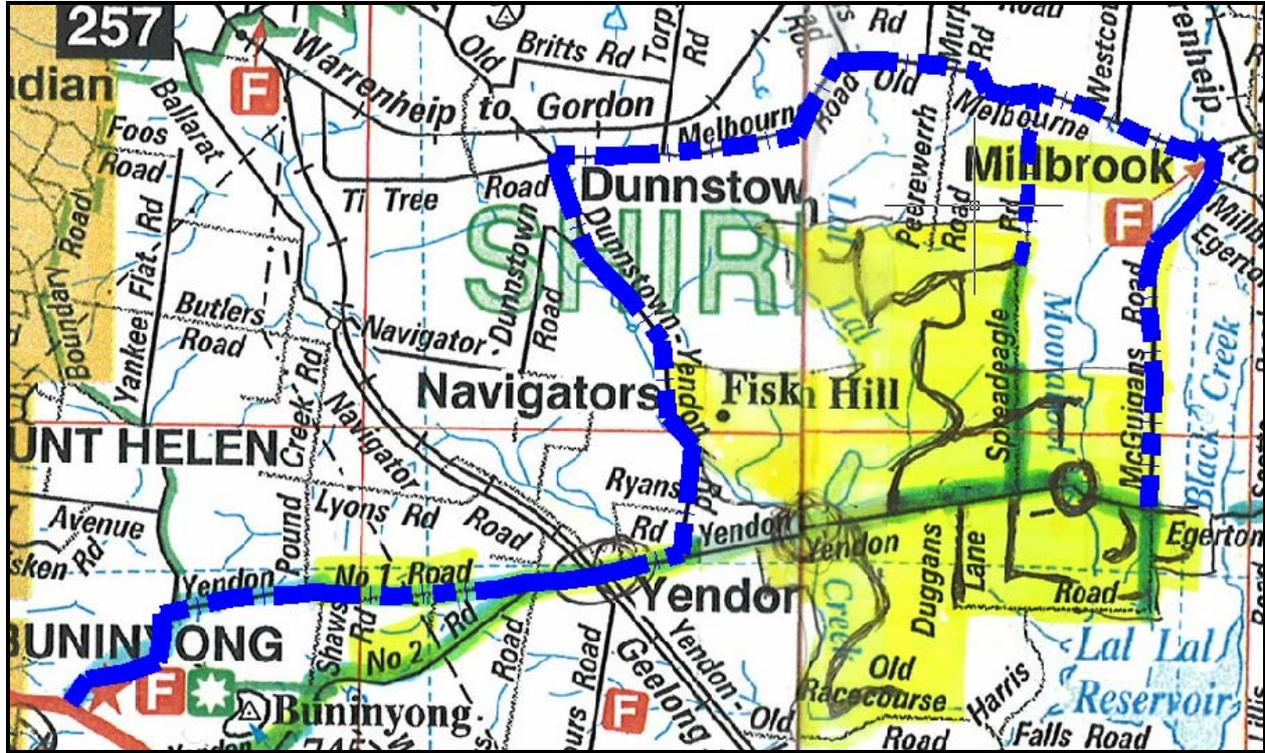
Figure 3 - Alternative Routes Yendon Site

Figure 3 shows the alternative access routes that were inspected:

This alternative route was driven on a clock-wise direction therefore all chainages adopted in the following section follow a clock-wise route.
