LAL LAL WIND FARM
YENDON SECTION
Feasibility of haulage routes

LAL LAL WIND FARM –YENDON SECTION FEASIBILITY OF HAULAGE ROUTES

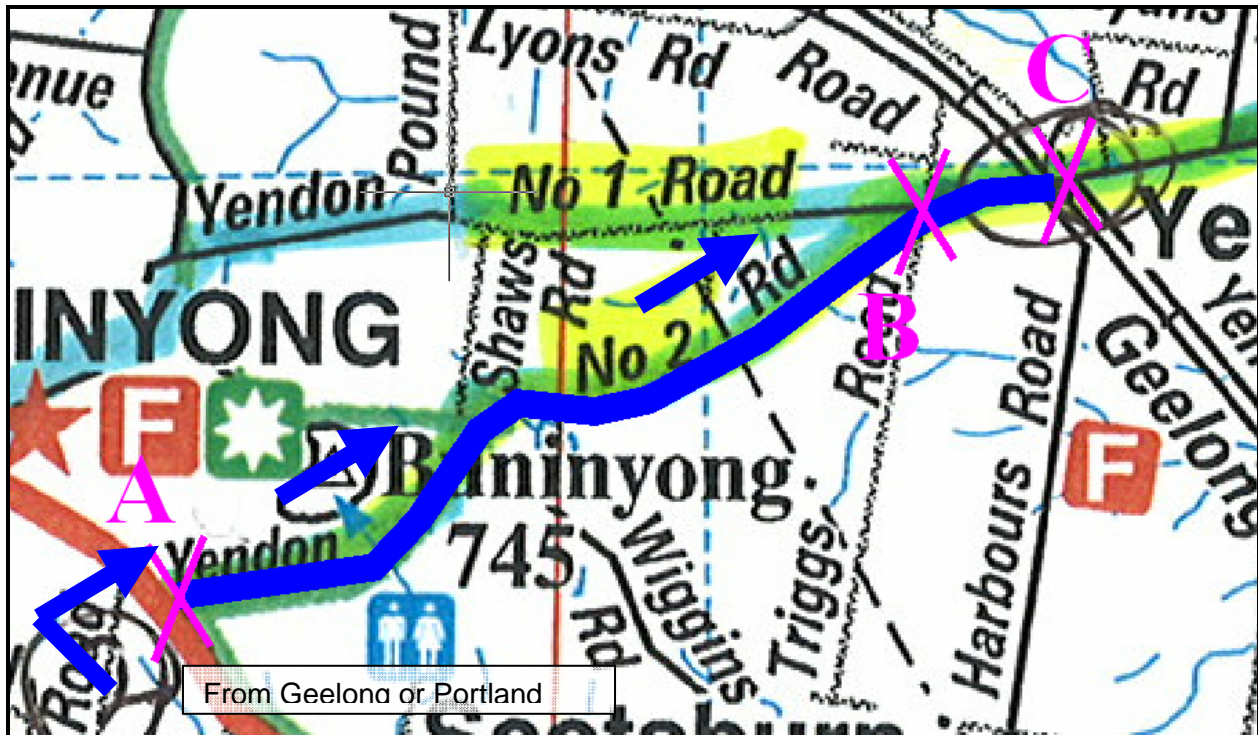
Figure 1 – Yendon Section - Yendon Road No2 Access Route

Access to both sections of the Site is expected to occur from the Midland Highway. For the purposes for this report Cardno Grogan Richards broke-down both sections into segments from A to V in the case of the Elaine Section and segments A to S for the Yendon Section. The following figures depict the routes that were analysed:

Continues on Figure 2
